Navajo Abandoned Uranium Mine

Site Screen Report

Taylor Reid No. 3 AUM Site

January 2011

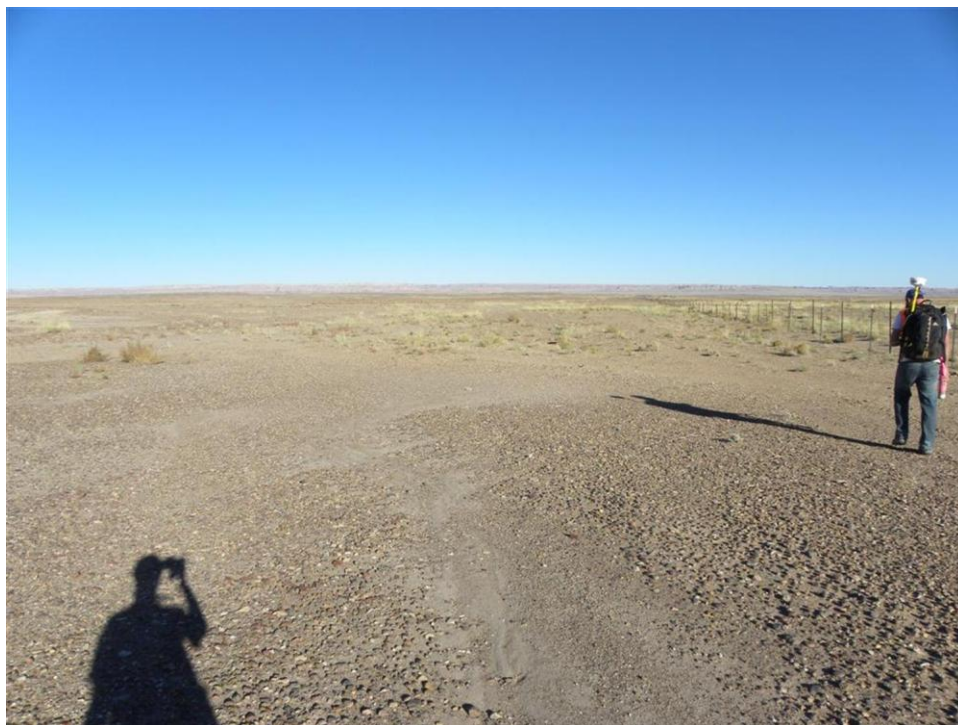
Photo 1. Taylor Reid No. 3 mine site

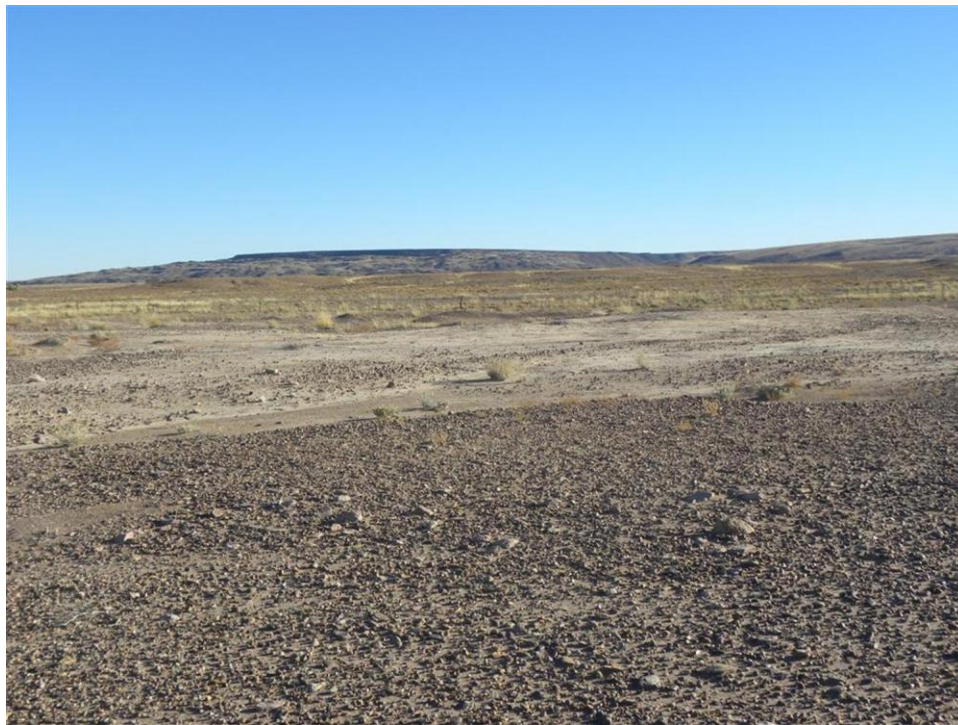
Reclamation cap throughout center of site with diversion channels

Photo 2. Taylor Reid No. 3 mine site, reclamation cap

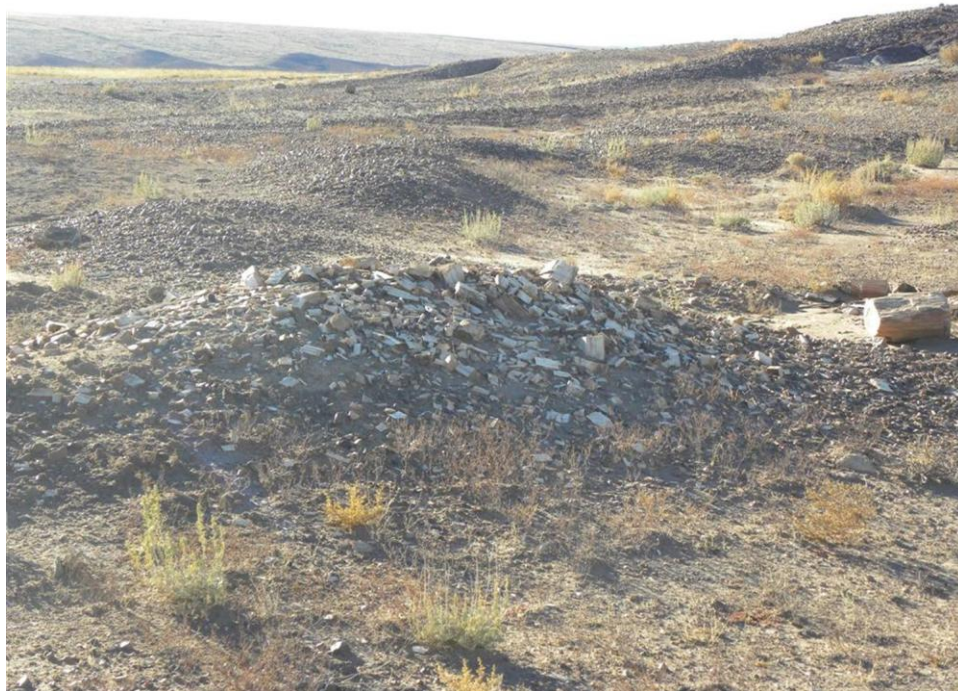
Waste pile 15' x 10' x 3' broken rock and petrified wood chips

Photo 3. Taylor Reid No. 3 mine site, waste pile

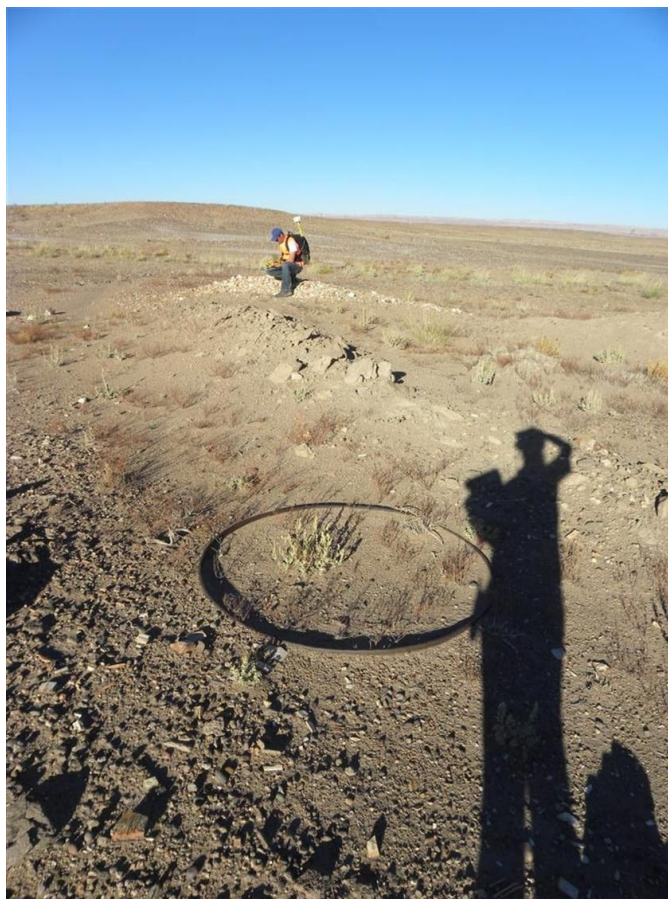
Photo 4. Taylor Reid No. 3 mine site, waste pile and debris
